Cornwall Dune and Beach Management Plans

Prepared for
Cornwall Council

April 2015

1 Introduction

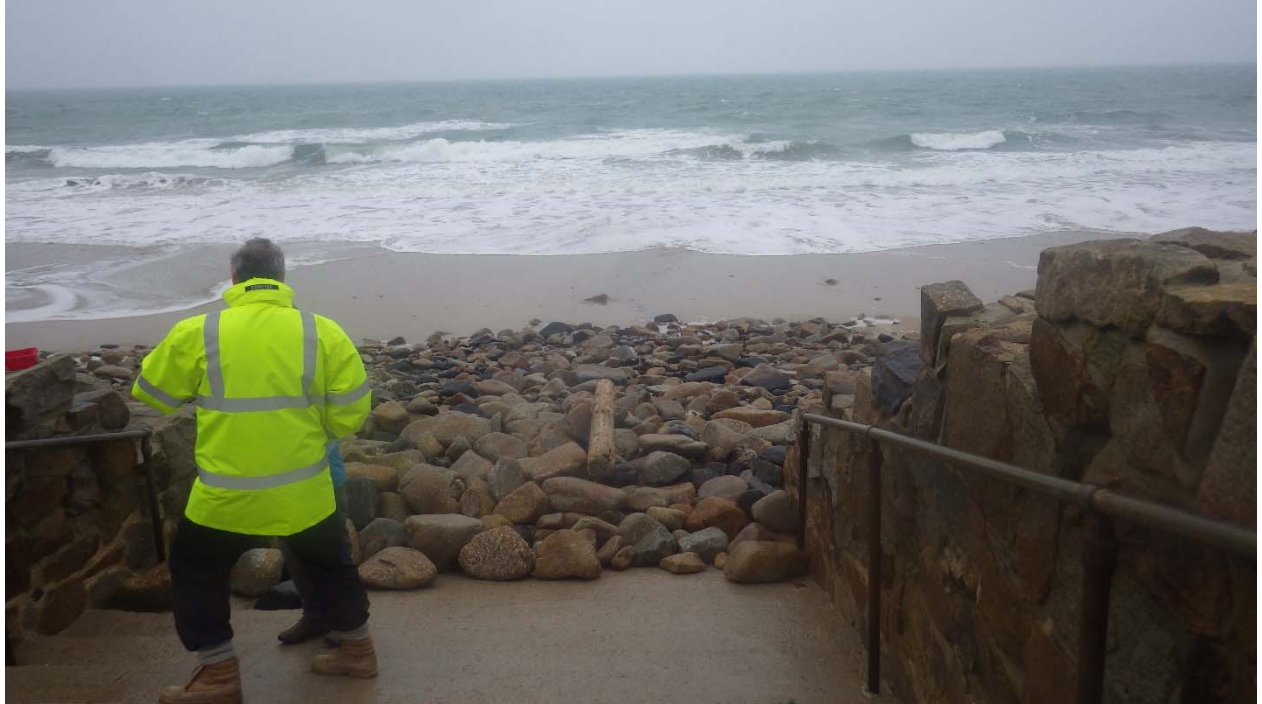
Photograph 2.1

At the eastern end of the beach there is an area of rocks at the bottom of the slipway (see photograph 2.1). Residents stated that these were deposited here recently (over the past 3 weeks; i.e. February 2015) and that they need clearing as in the past they have prevented RNLI and lifeguard access to the beach.

Residents noted that the sand level had dropped drastically in the vicinity of the slipway and café in the last couple of weeks – estimated at 4m drop. Sand usually comes up to the bottom of the hand rail (see photograph 2.1).

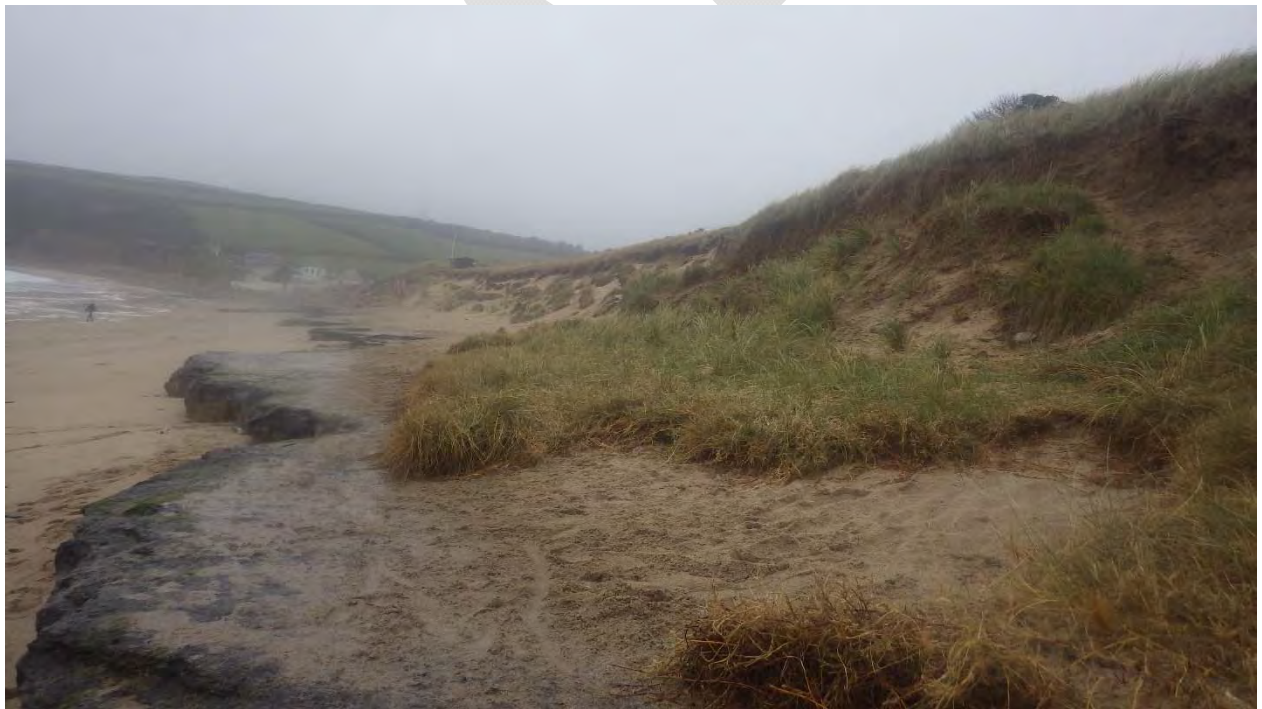
Photograph 2.2

There are significant areas of peat exposed which residents stated are not usually visible (see photographs 2.2, 2.3 and 2.4) indicating lower beach levels.

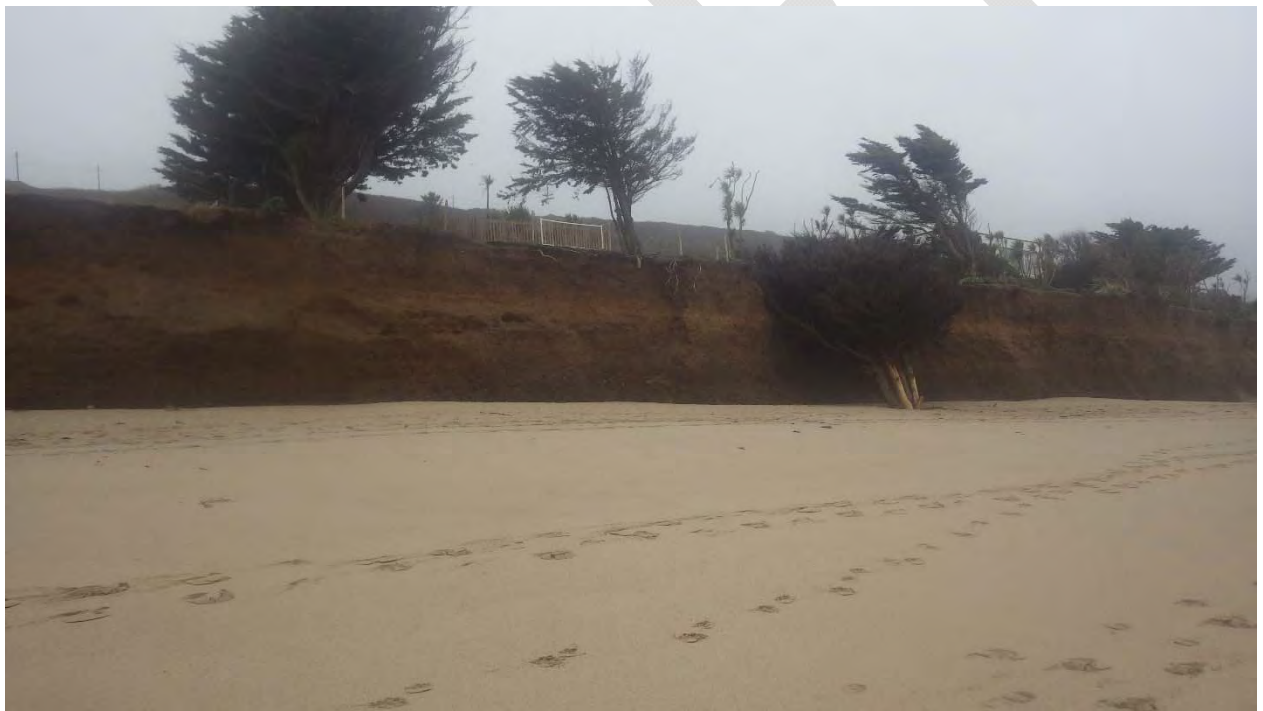
Photograph 2.6

At one property trees were lost from the garden due to erosion during these storms, and one tree remains on the beach (photograph 2.6). Beach levels have increased around the tree trunk. A buried electrical cable attached within the garden has also become exposed with one end hanging down the face of the eroded cliff to just above beach level.

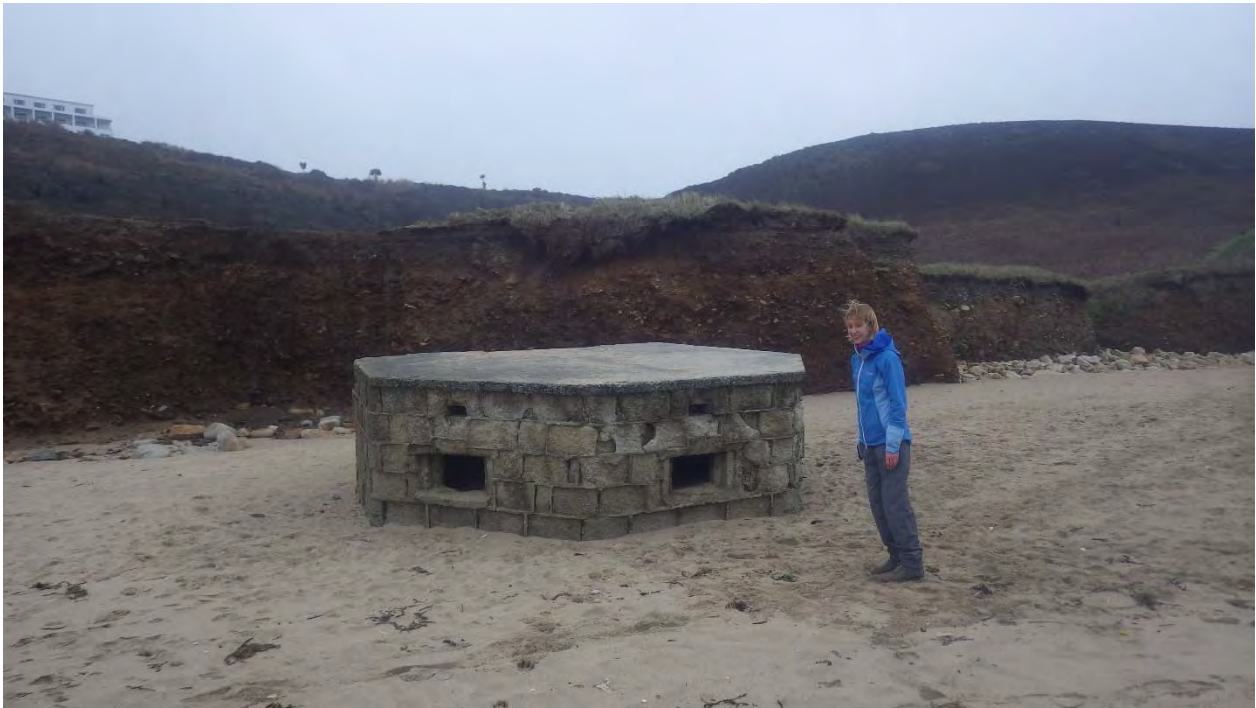
241
242 *Photograph 2.7*
243

The Pill Box at the very eastern end of the beach indicates higher beach levels at this location (photograph 2.7) as sand levels have increased around it. Residents noted that there has been erosion of the cliff behind the pill box. It was stated that in 1985 it was not possible to walk behind the pill box as it was too close to the cliff. Previous to this it was on the cliff top. Sand at present, has covered large rocks at this end of the beach, making walking and access from The Coast Path to the beach a little difficult to gauge safe footing. The erosion of cliff over recent years has forced the coast path, which previously ran along the cliff edge, onto the beach at this point (see photograph 2.8). The coast path requires key consideration of safe route and access. The route from the beach at the western end is via the sandbar café, again with residents noting that there were not enough access points along the beach.

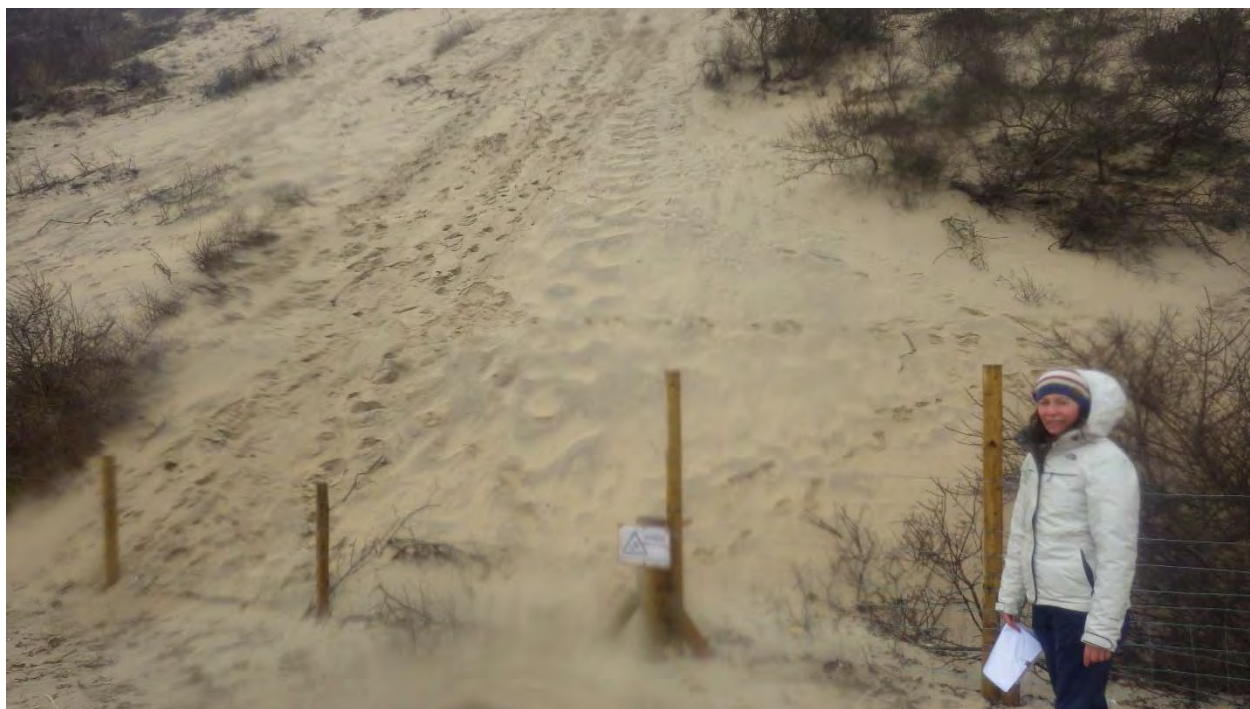
Photograph 3.2

The team walked north east from here towards Harvey Towans. At the south eastern edge of the site fencing has been constructed to prevent access to the steep, unstable sand dune face with a walkway to channel access from the holiday chalets onto the beach. Along one section the sand seems to have built up and a new higher fence has been added (see photograph 3.1). Along the adjacent section the additional fence has not been added and footprints in the sand indicate the visitors have been stepping over the low fence to climb the dune face (see photograph 3.2).

- Review access management to restrict access to steep eroding dune faces.
- Further information required from site managers to fully understand the issues at this site.

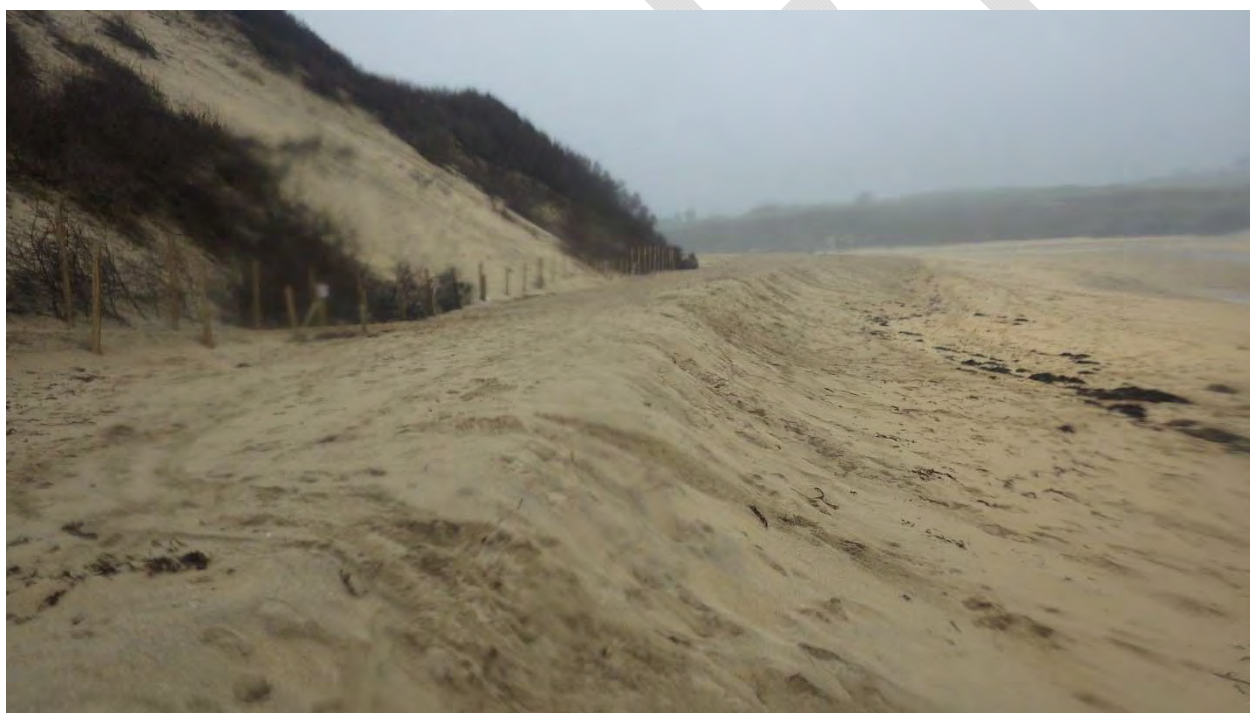
Photograph 3.3

There is a step in the beach immediately seaward of the toe of the dune. This could be the result of wave action (see photograph 3.3).

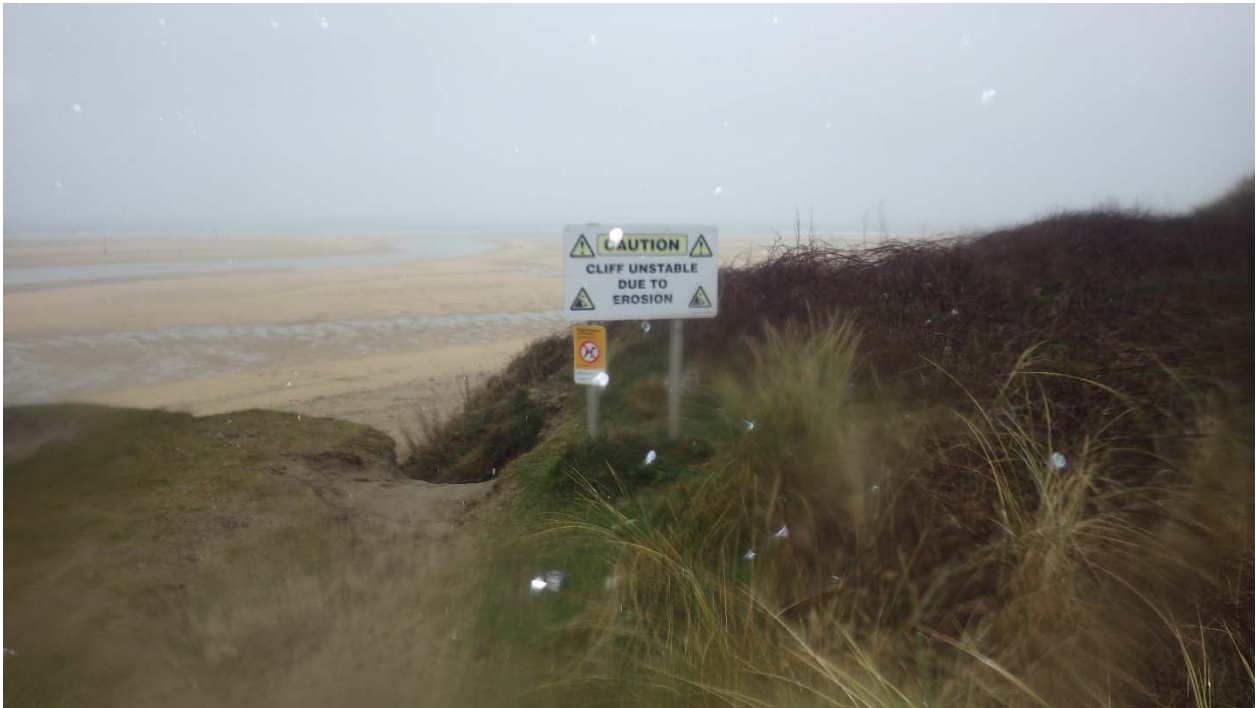
Photograph 3.4

visitors have been walking down the steep dune face to access the beach, most likely because it is a more direct route from the car park to the beach than the designated marked routes (see photographs 3.4 and 3.5). Another such access point forms the most direct route from the properties within the dunes to the beach (see photographs 3.6 and 3.7). The South West Coast Path also runs through the dunes.

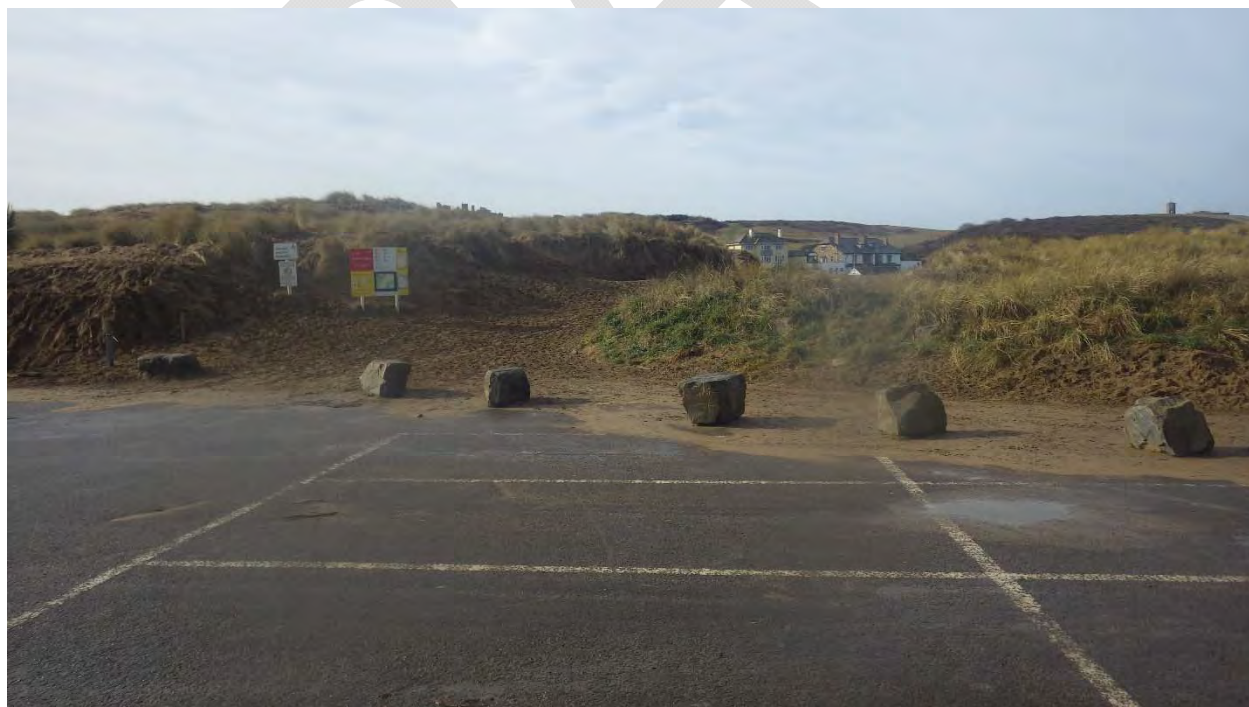
399
400 *Photograph 4.1*

- The car park requires clearing of sand fairly regularly. As the time of the site visit it could be seen that the sand had been pushed to the edges of the car park forming high steep dunes (see Photograph 4.1). In the past, a tractor was used to recycle sand from the dunes to the beach, but this ceased with funding cuts described above. When sand is cleared from the car park it cannot be returned to the beach as it is considered to be hazardous material because it could contain oil, diesel etc. Local farmers can therefore take the sand under a bi-law. This results in sand being lost from the system.

391 • The majority of sand movement into the car park occurs during the Winter. The timing of sand
392 clearance from these areas could be planned. For example, it could be undertaken at the start and
393 end of the busy summer season.

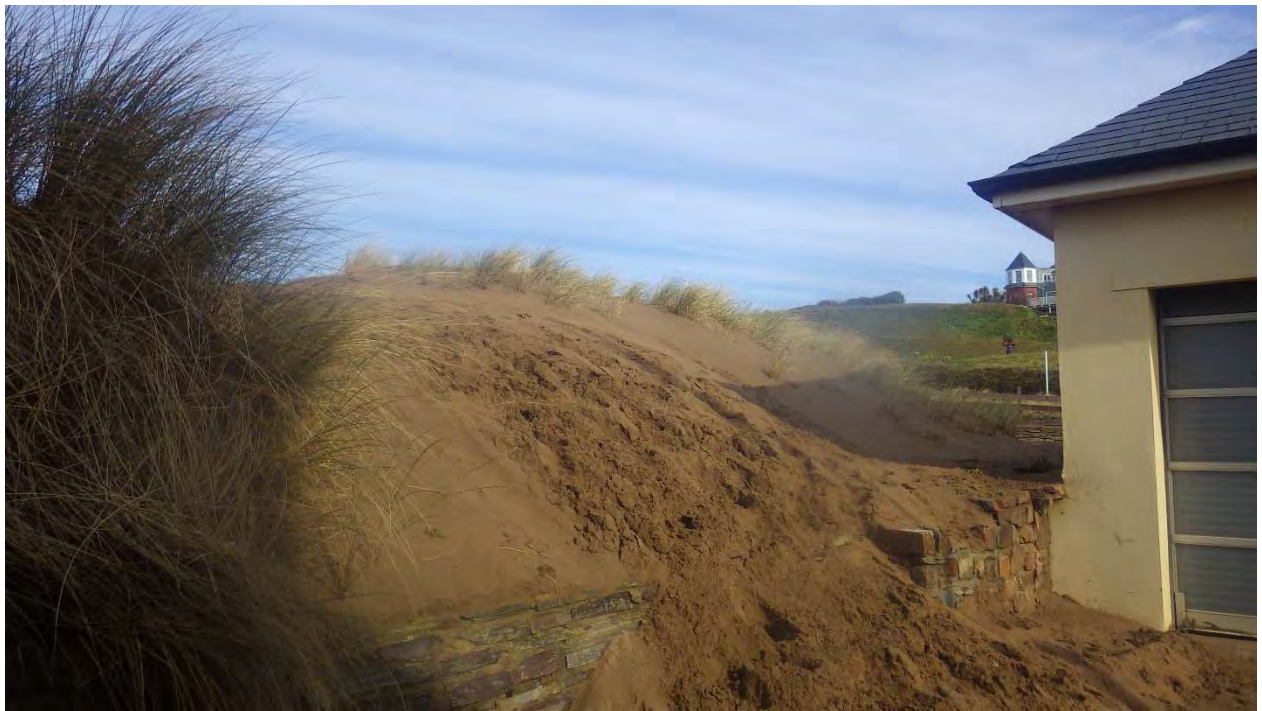
Photograph 4.2

- Sand had built up behind the RNLI buildings where the dunes are migrating landward. Again this requires resources to clear (see Photograph 4.2).
- The main access path to the beach, which also serves as the access to the permanent disabled beach huts, is tarmac and had significant sand cover at the time of the visit with sand having buried the wall along the side of the access path (see Photograph 4.3). This will take significant work to clear and hence significant costs.

394 • A staggered sleeper system could be placed within the front-face of the dunes to help slow the rate
395 of dune accretion/climbing.

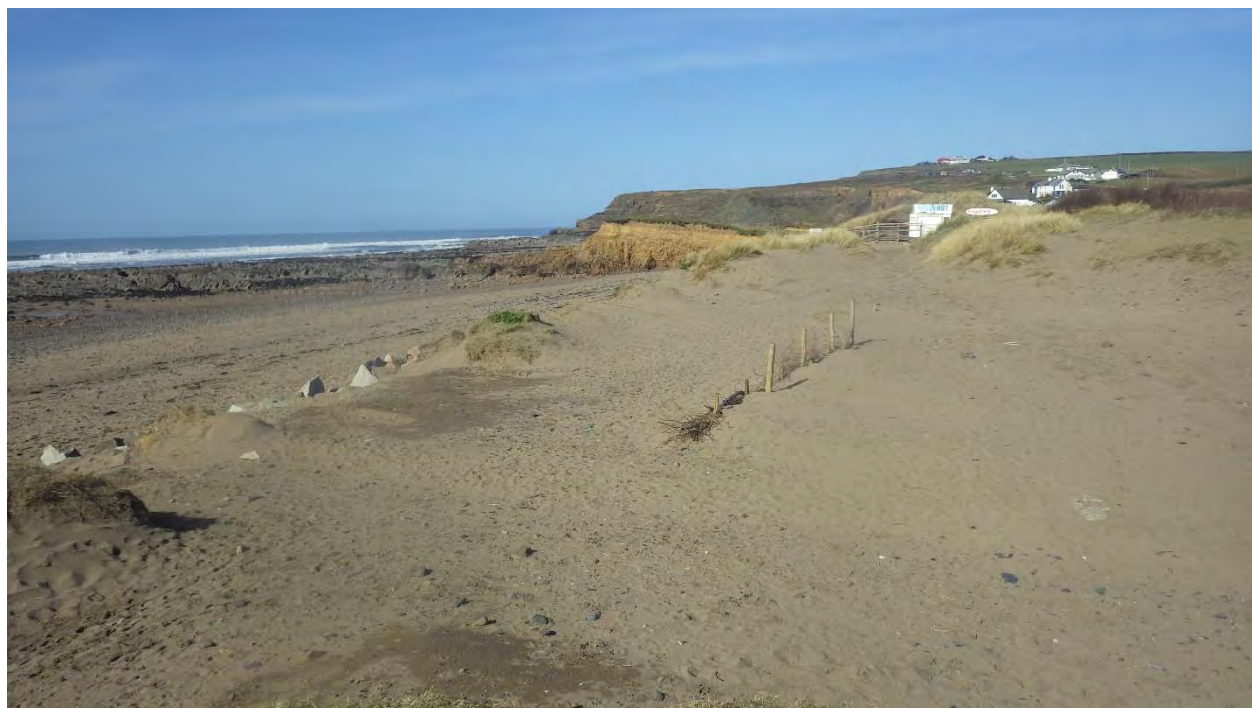
Photograph 5.1

The front face of the dunes is eroding and there are boulders, which used to be buried. In the past Gareth and volunteers have implemented dune management techniques to trap sand, including a fine mesh fence, although it did not prove successful and was unsightly. More recently, techniques such as

planting Christmas trees and willow coppice have been implemented to help stabilise the dune front. The willow is cleared from another site and so is a waste material being reused. Where willow has been planted the dunes have begun to build behind (see Photograph 5.1).

- Gareth would like to undertake a coordinated Christmas-tree planting event during winter 2015/2016.

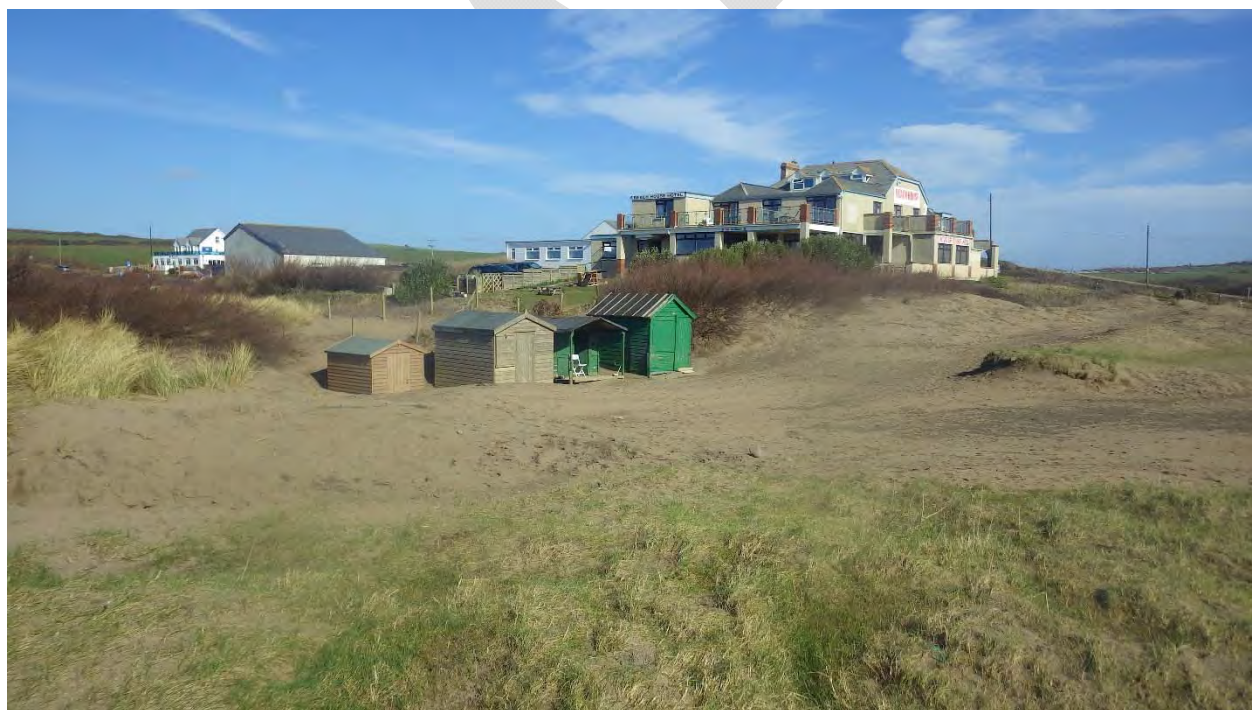
Photograph 5.2

- In front of the privately owned beach huts, sand builds-up restricting access (see Photograph 5.2). During the site visit, we were informed that sand has built up to the roof of the beach huts.

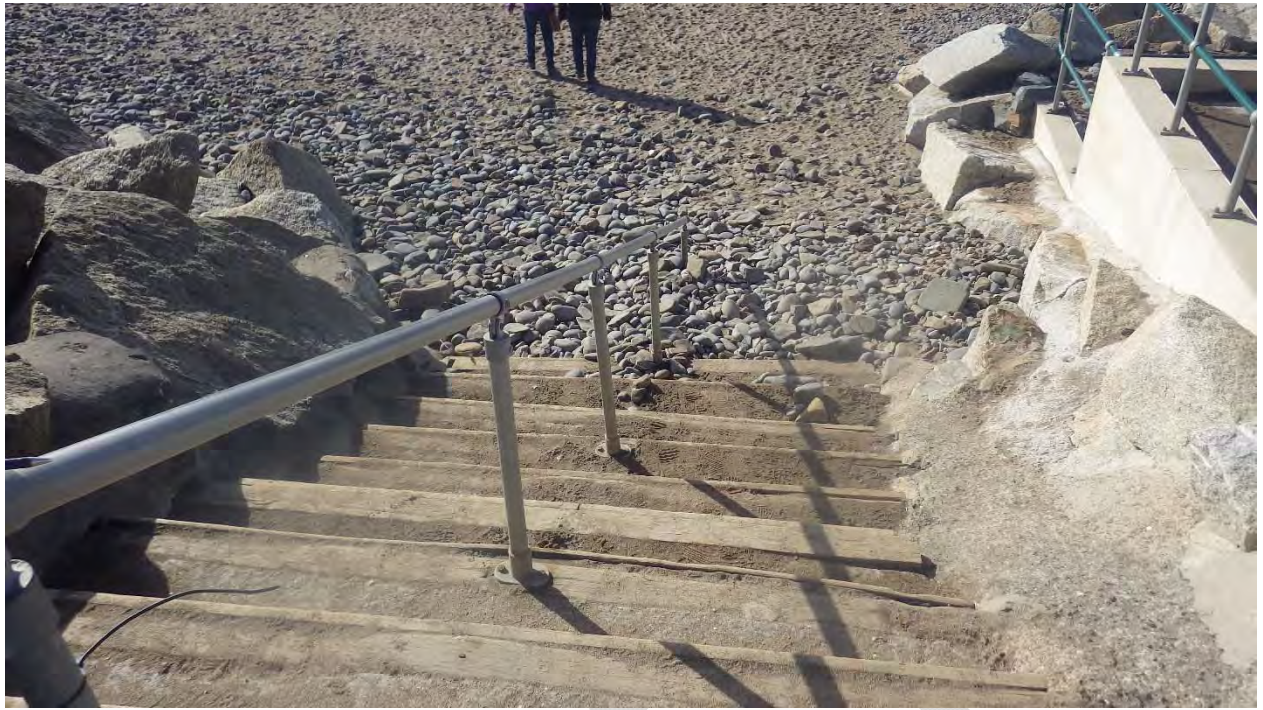
Photograph 5.3

Seaward of the car park, pebbles were removed from the beach last winter to leave a significant drop at the foot of the access steps and disabled access ramp. The cobbles are now building back up and the bottom few steps are buried beneath the cobbles (see Photograph 5.3).

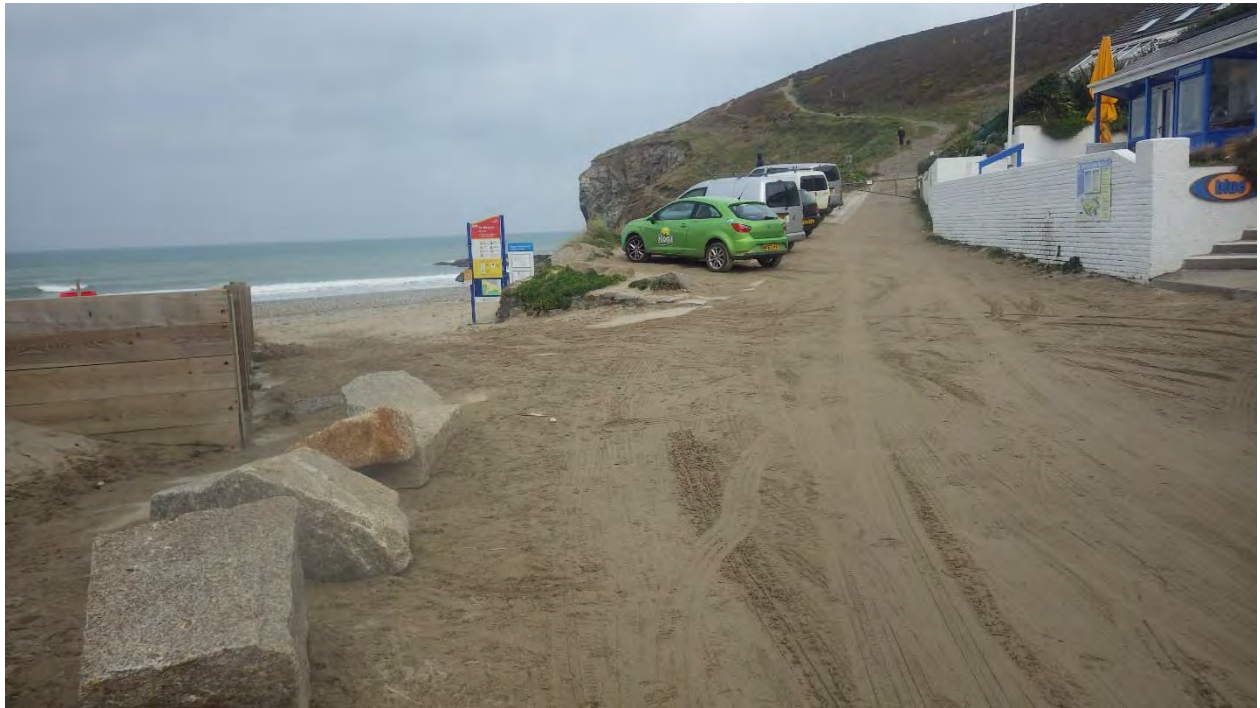
Photograph 6.1

-
- The access path to the beach via Beach Road (opposite Blue Bar) is covered by sand and is uneven. Cornwall Council and St Agnes Parish Council are working together and will soon implement a project to improve the beach access path and provide disabled access to the beach in order to maintain and fulfil the criteria requirements for Blue Flag status and the Cornwall Council Seaside Award (see Photograph 6.1).

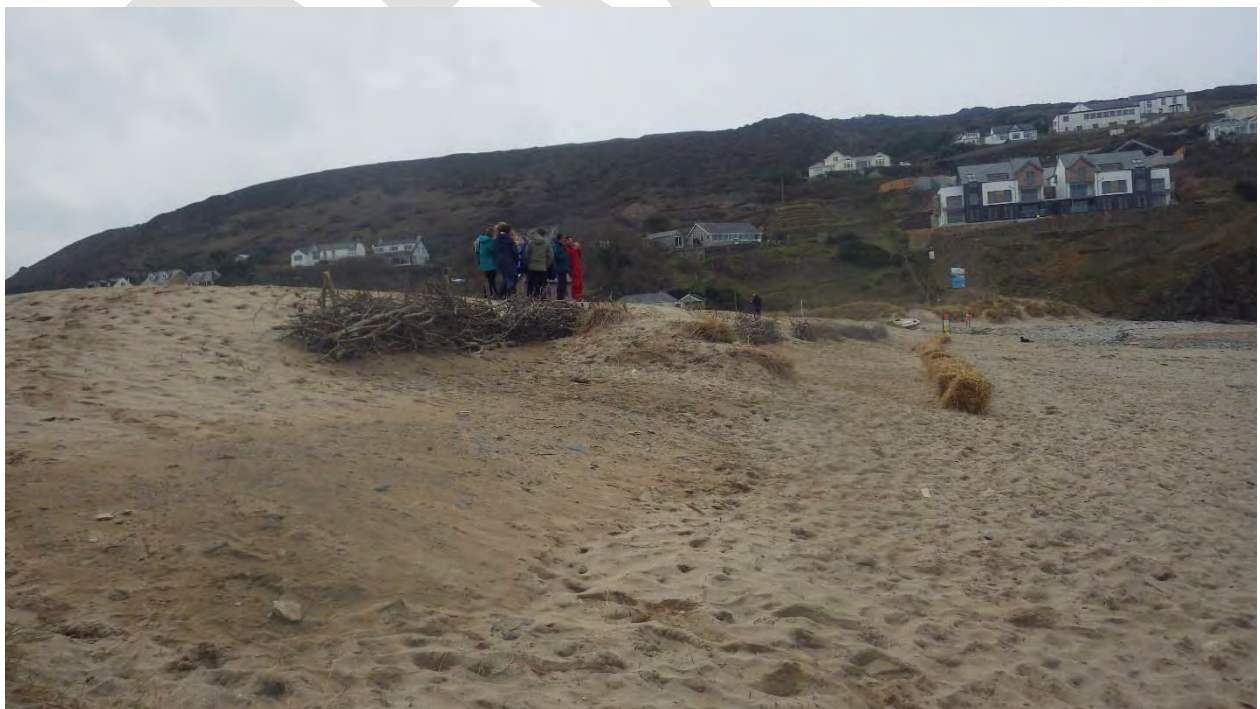
Photograph 6.2

- Sand bails located within the dune face, placed 3-4 weeks ago (see Photograph 6.2), along with topping of the existing dunes and reshaping of the sand. The community are divided by the method of removal and reshaping of established dune and there is concern for the remaining patch of dune adjacent to the stream. Sand is accumulating around the bails, although children do play on them and horses eat them. There is dispute within the community regarding the eventual required height of the dunes and protection of the seascape view point from behind the dunes.
- Brush Wood fencing.
- Hoping to plant Marram Grass.

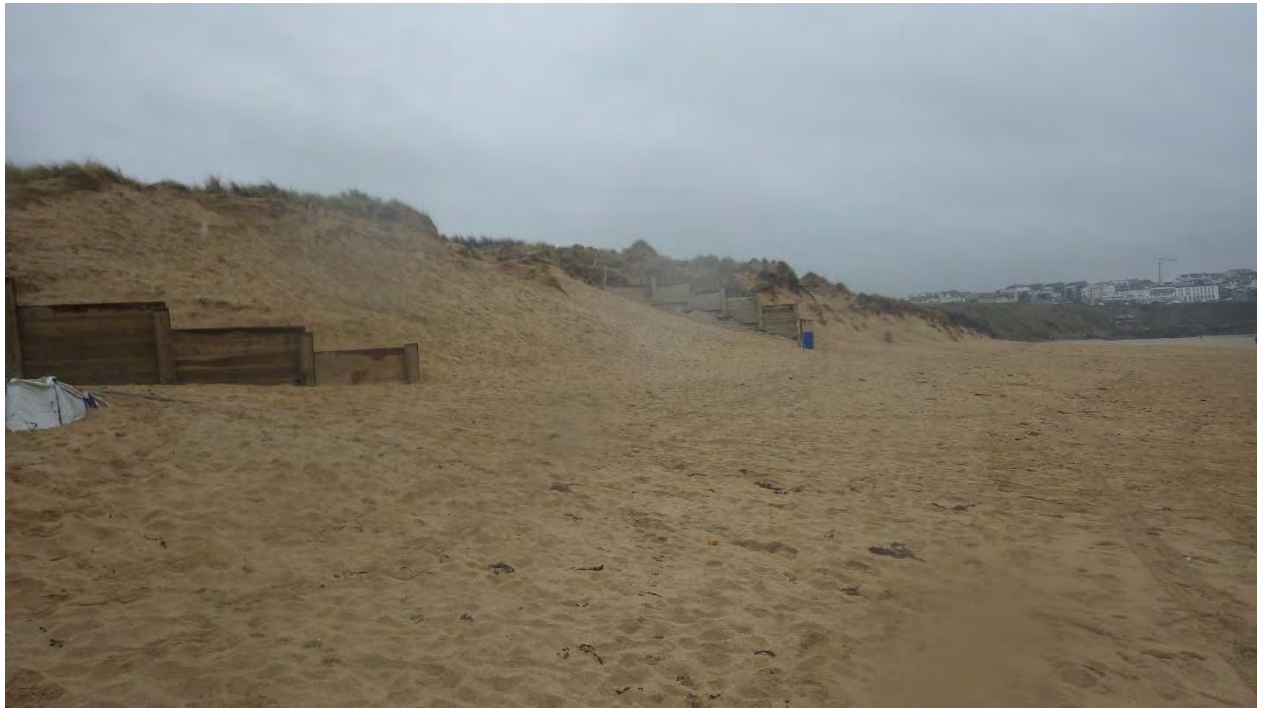
Photograph 7.3

565 The dunes adjacent to the access path to the right of the RNLI Life Guard station have been stabilised
566 and protected with a solid dune fence put in during March 2014 (see Photograph 7.3).

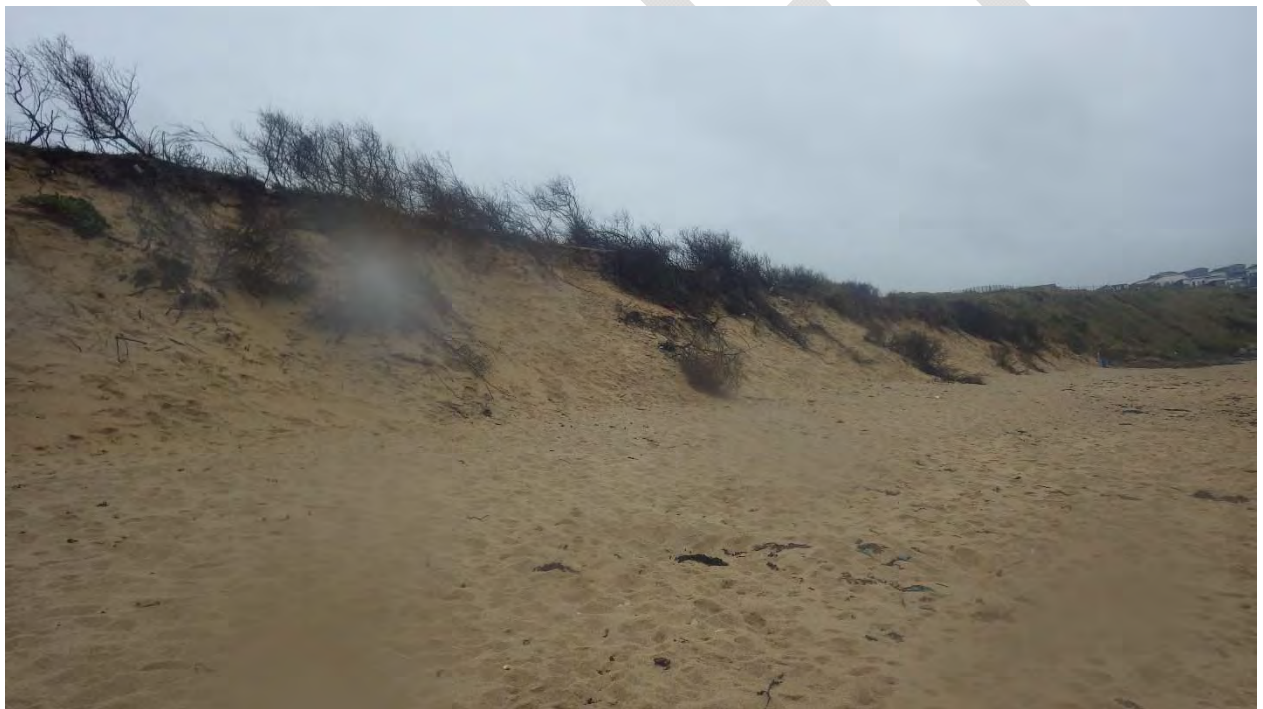
Photograph 7.4

571 At the top of the dunes, much of the dune vegetation was burned on the day of the site visit. This was
572 due to accidental fire and not controlled burning (see Photograph 7.4).

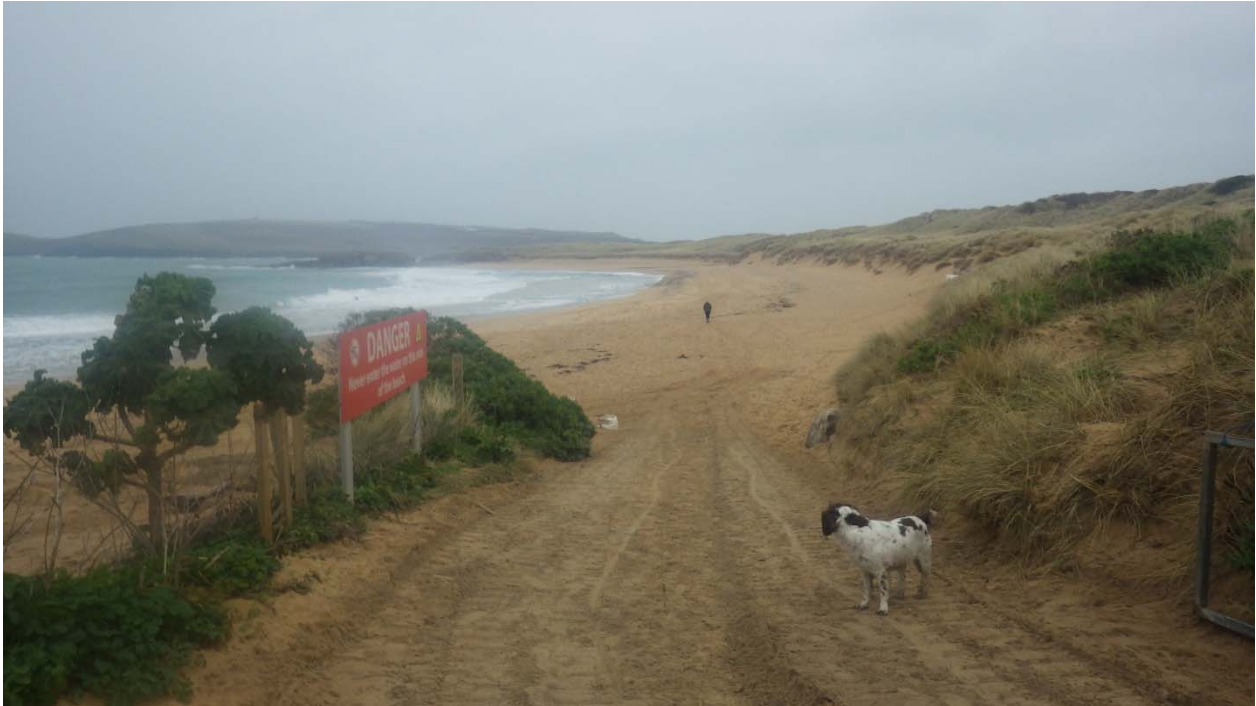
Photograph 8.1

The access path was buried beneath sand, as sand blows up the access path. The RNLI placed one boulder bag at the toe of the access path to assist in stabilising the bank of the footpath (see Photograph 8.1).

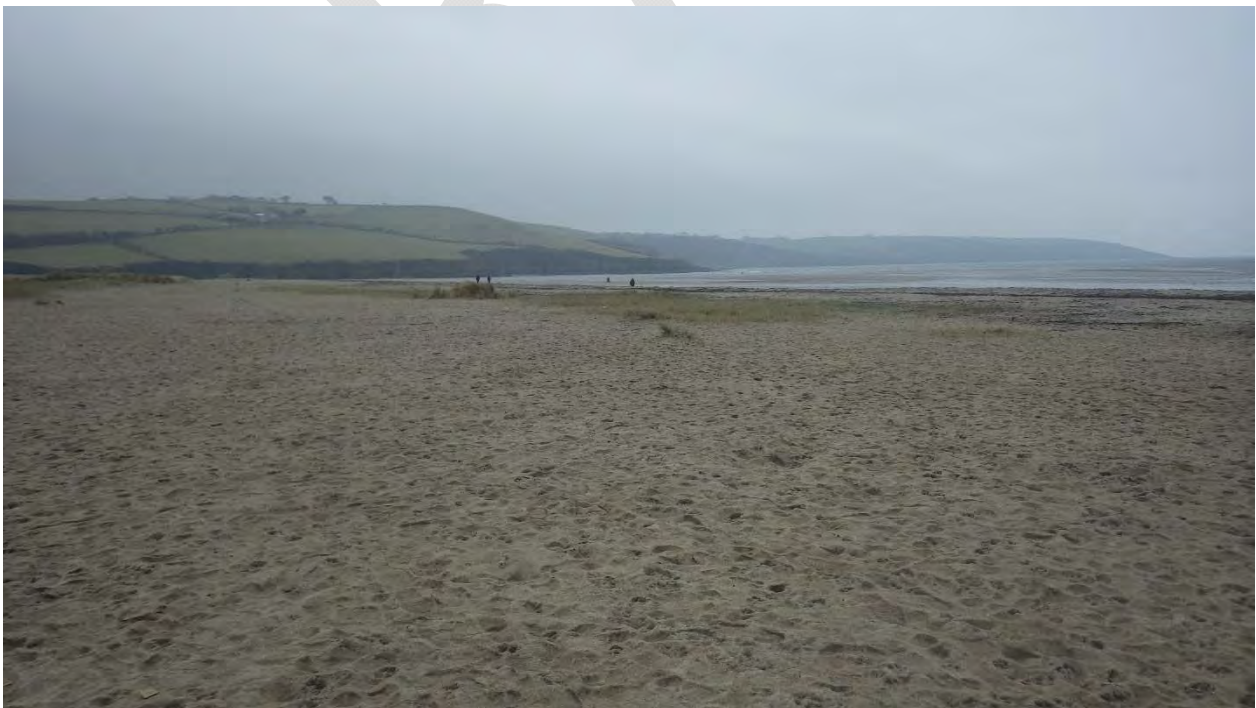
Photograph 9.2

691 Along the dunes, there is clear evidence of dune growth with the formation of embryo dunes and young
692 dune grass (see Photograph 9.2). Marram Grass is growing well and effectively stabilising the dunes. This
693 is likely to be a response to a dune planting programme in the 1980's when the dunes were fenced off
694 and Marram Grass was planted. There are gaps within the embryo dune, and it was questioned if they
695 will join to form one long ridge over time as sand continues to accumulate.

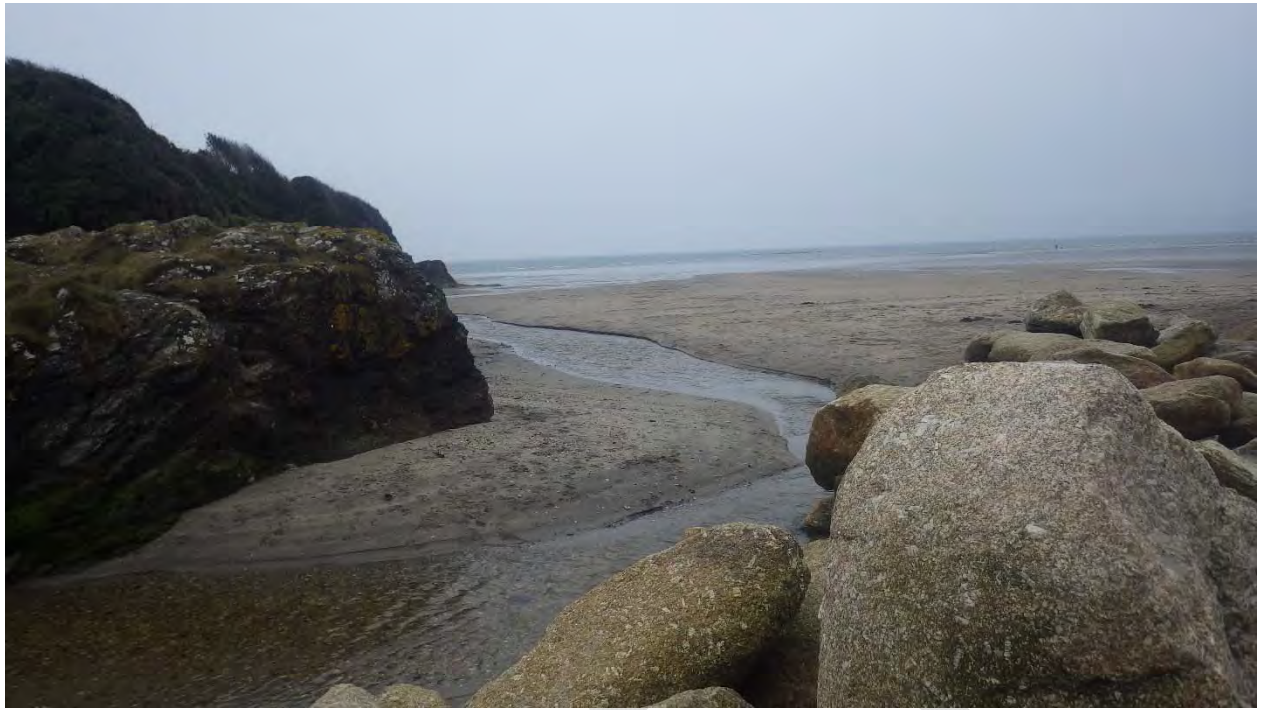
707 During the summer, the stream flows out and over the east bank of the river (only over a small isolated
708 area at the bottom of the cliffs where Trill Farm is). Boulders were placed in the stream in the late 1970's
709 to help stabilise the bank of the river at a pinch point (see Photograph 9.3 and Photograph 9.4). They
710 were placed at the same time as a scheme at Polmear, when before it used to flood during high tides.
